Manhole Inspection Summary

Manhole # S25CC_029MH

Insp Date: **8/20/07 11:45 AM**

Location Address: **1117 CARROLLTON AVE**

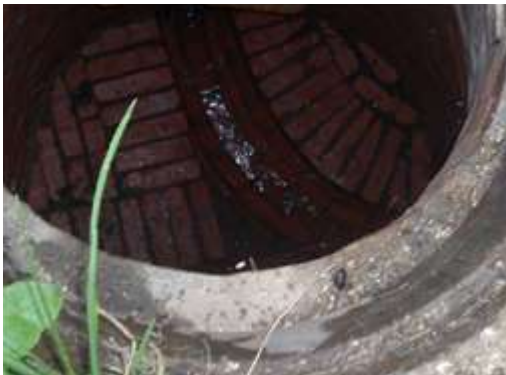
Defect 2

Offset: **2** (in.)

FRAME OFFSET

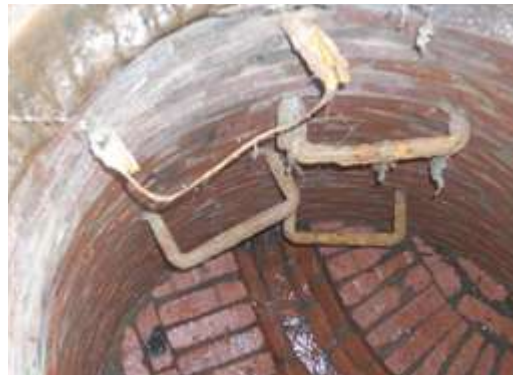
Defect 1

Count: **4** Missing: **0** ☒ **Corroded**

CORRODED STEPS

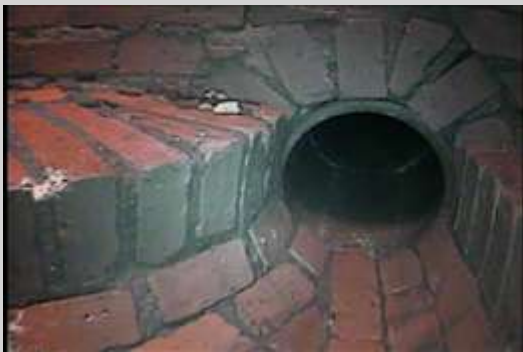
12 O'Clock Outflow

8 in. Circular Gravity Sewer
Pipe Out @ 12 O'Clock

Pipe Height: **8.4** (in.) Rod and Bar (Angled)
Pipe Material: **Clay** ☐ Pipe Lined
Invert Depth: **7.71** (ft.) Flow Characteristics: **Slow**
Deposits: ☒ None ☐ Mud ☐ Sludge ☐ Debris ☐ Grease
Silt Depth: (in.) Deposits Extent:
Infiltration: **Weeper** Pipe Seal Cond: **Sound**
